## CITY OF CAMPBELL Community Development Department

## NOTICE OF PUBLIC HEARING

please refer to: 1875 S. Bascom Avenue

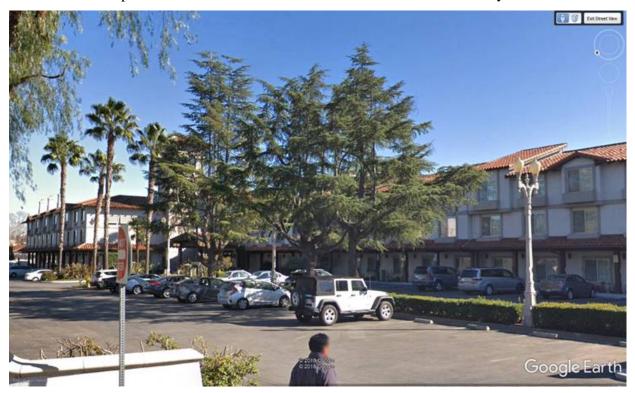
This picture shows the 3 Deodar cedars in the same parking lot strip in front of the DoubleTree Hotel. The canopies appear healthy and green. Previously there were 4 Deodar cedars but one experienced a whole tree failure. It was removed by another tree company in addition to the cedar on the far left after experiencing a large limb failure.

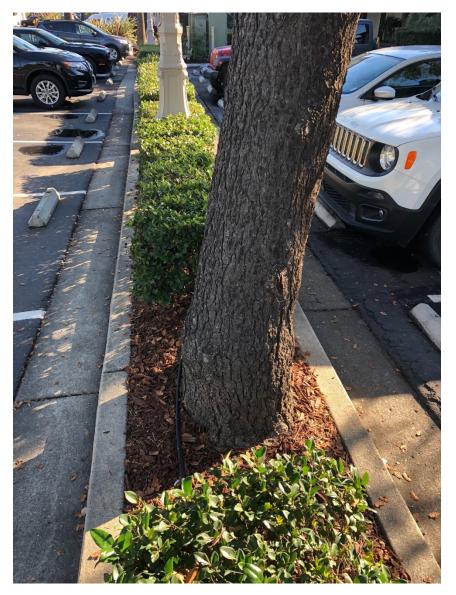
cause more harm than good. The issue is the available growing space for the roots. The damage is already done and can not be mitigated at this point. These trees can not grow more stabilizing roots in the space they have and the structural integrity of their roots systems is the main concern and the reason they have been proposed for removal.

This photo shows the small growing space for these cedars. Ideally, the roots would be able to grow 15-20' from the trunk. It is obvious that is not possible while growing in a parking lot. The roots of these trees have the ability to grow along the parking strip but that is not sufficient to provide the tree with adequate stability.

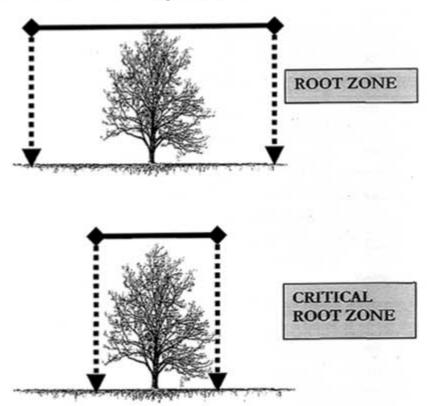
## Illustration 2-1: Root zone vs. Critical root zone (CRZ)

This image illustrates the area around a tree that makes up its root zone and what makes up the critical root zone. The critical root zone extends from the trunk to the drip line of the tree. Looking at the above photo one can see that the critical root zone of these trees is almost entirely compromised.
